Office of the Lake Macquarie and  
Catchment Co-ordinator

**Review of the current impacts of  
Dredge Spoil Islands and water  
circulation on adjacent seagrass  
beds – Swansea Flats**

March 2004

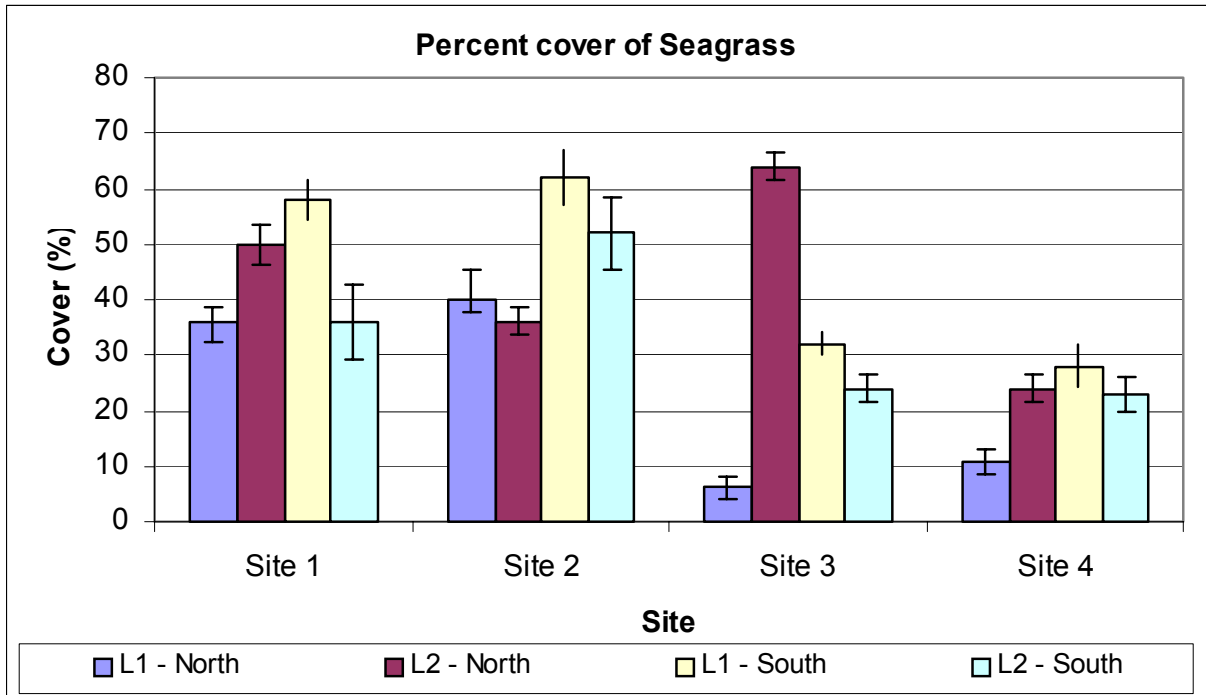
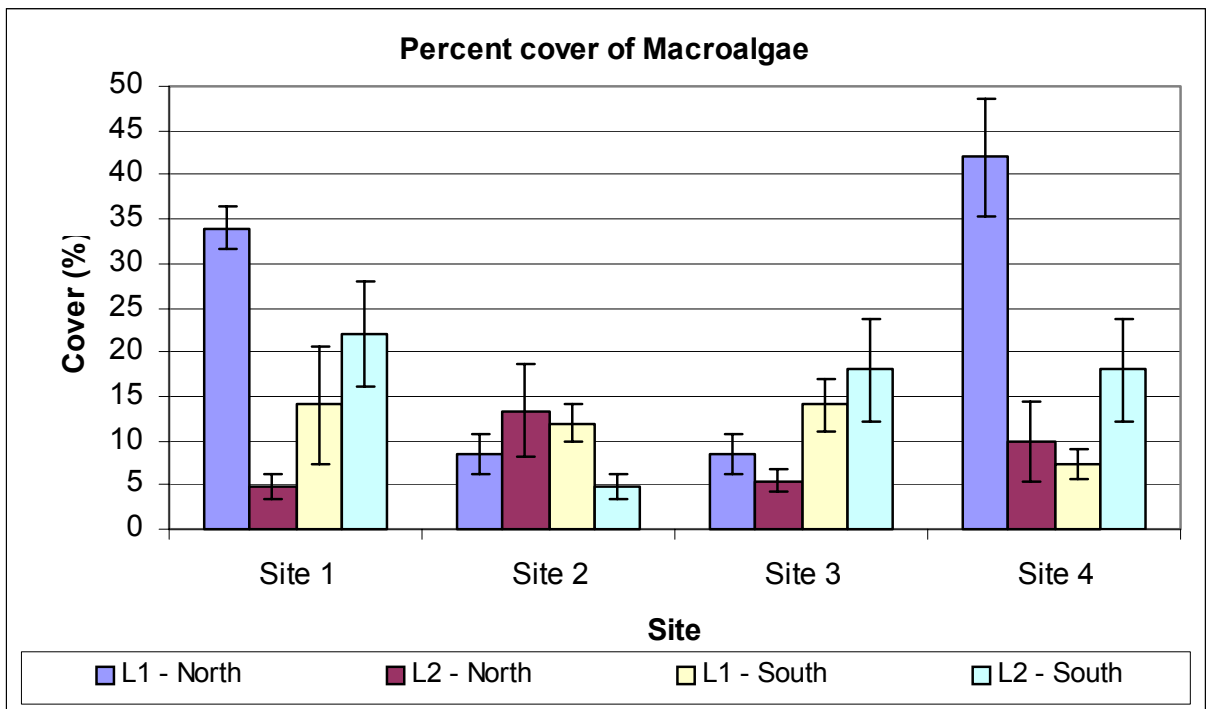
FIGURE 3.2

The mean ( $\pm$ SE, n=5) density of seagrass was highest at sites 1 and 2, furthest away from the lake foreshore (refer to **Figure 3.2**). This pattern was also evident in relation to the island foreshores, with the offshore locations consistently showing a higher density of seagrass than the inshore locations. Considerable variability was evident between all sites and locations, a pattern that has been consistently found in estuaries within New South Wales.

Small scale variations were evident in the mean ( $\pm$ SE, n=5) density of drifting and attached macroalgae between all sampling points. Density was greatest at sites 1 and 4, inshore on the northern foreshore (refer to **Figure 3.2**). Generally, the mean macroalgae density was less than 20 per cent.

Mean ( $\pm$ SE) Percent Cover of Seagrass and Macroalgae at each Site

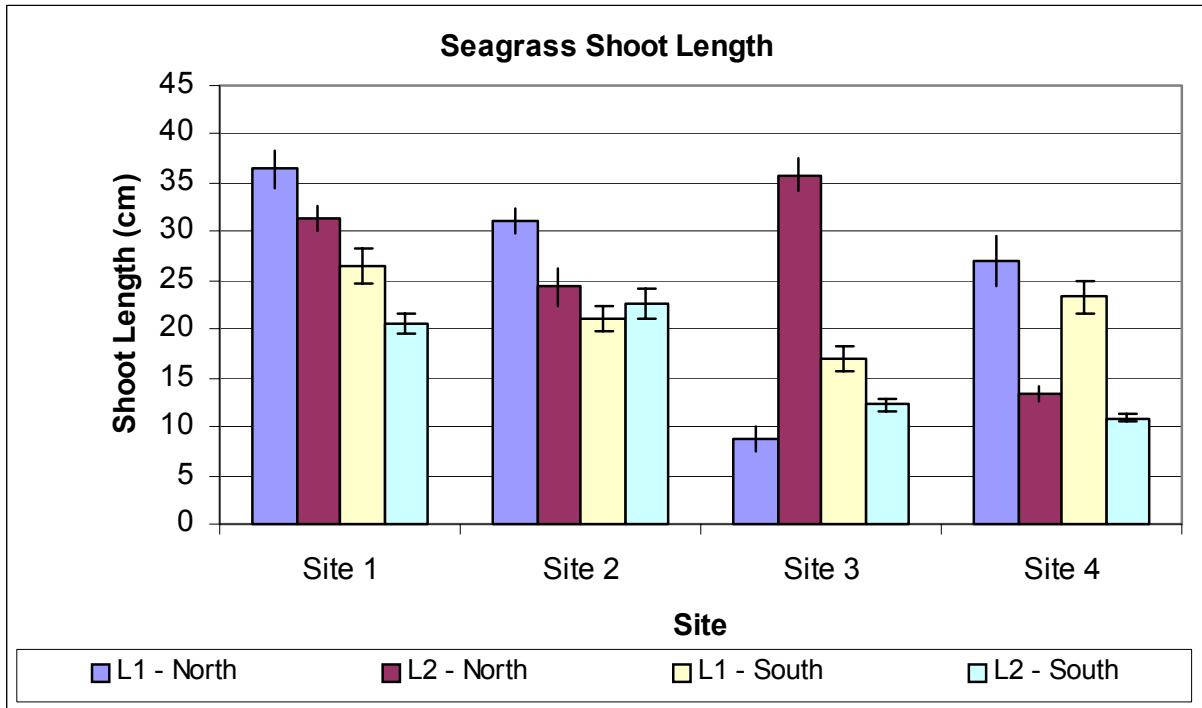
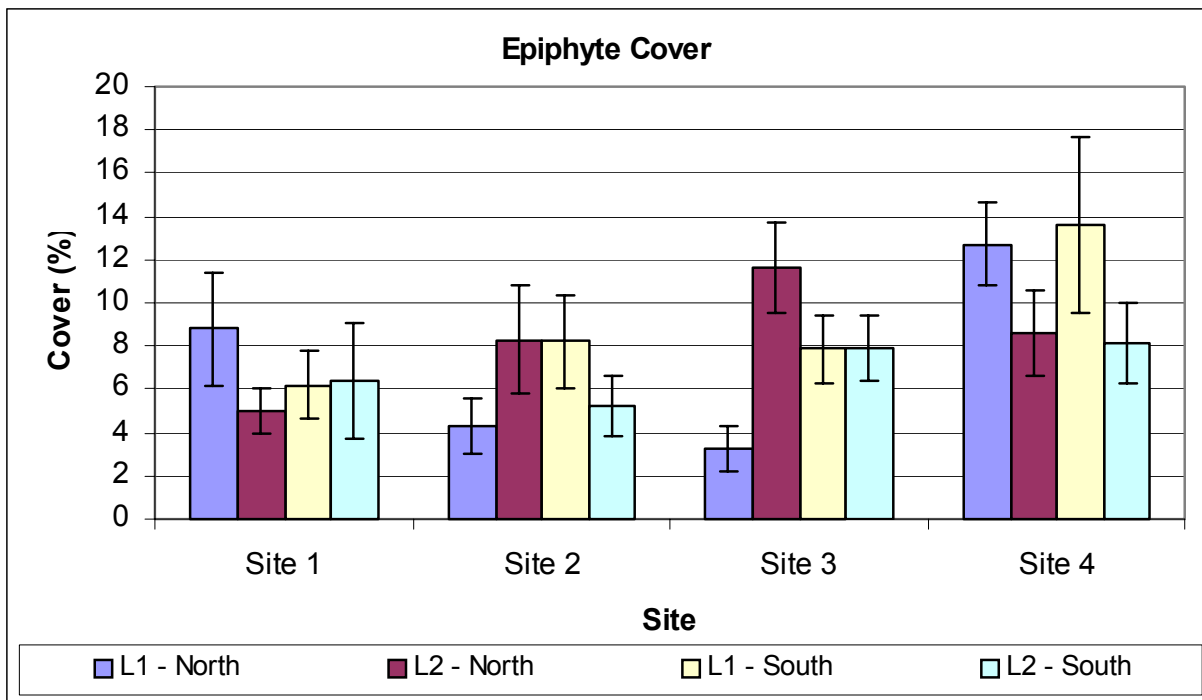
The mean ( $\pm$ SE, n=10) shoot length of *Zostera capricorni* varied significantly between all sampling points (refer to **Figure 3.3**). In general, shoot length was greatest at sites 1 and 2, with the exception of the northern, offshore, site 2 sample. At site 1, shoot length varied significantly between the northern and southern foreshores, whereas at site 4, the inshore samples were significantly different to the offshore samples.

There was no significant difference in the mean ( $\pm$ SE, n=10) epiphyte cover between any of the sampling points (refer to **Figure 3.3**). Epiphyte cover ranged from a mean 3 to 13.5 per cent. Epiphyte cover was highest at the inshore locations of site 4, for both the northern and southern foreshores.

**FIGURE 3.3**  
**Mean ( $\pm$ SE) Seagrass Shoot Length and Epiphyte Cover at each Site**
